# Restoration of an “At Risk” Tooth

Replacing an old amalgam with a fiber mesh and a nano-composite.

By Grant T. Chyz, DDS

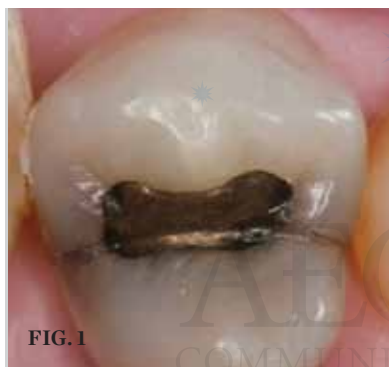
The patient presented with signs of recurrent decay with mesial and distal enamel cracks on tooth No. 12 that suggested a heightened risk of internal cracking (Figure 1 and Figure 2). While the patient was looking at the intraoral photograph of the tooth, the hygienist explained that treatment of teeth that exhibit cracked “walls” (the term the author and his team uses during discussion with patients) can be completed with a composite filling if the tooth does not have cracks extending into the

**PREOPERATIVE CONDITION (1.)** Tooth No. 12 showed signs of recurrent decay with mesial and distal enamel cracks. **(2.)** The pretreatment radiograph. **FULL CRACK EXAMPLE (3. THROUGH 5.)** Pulpal floor cracking (as in this asymptomatic tooth) would have changed the treatment plan and the prognosis. **PREPARATION STEPS (6.)** The amalgam was carefully removed. **(7.)** Recurrent decay was removed. **(8.)** Cracks extended down the proximal walls of the tooth but did not extend onto the pulpal floor. **(9.)** The marginal ridges were prepared as conservative boxes, resulting in a narrow but deep preparation with round internal line angles.

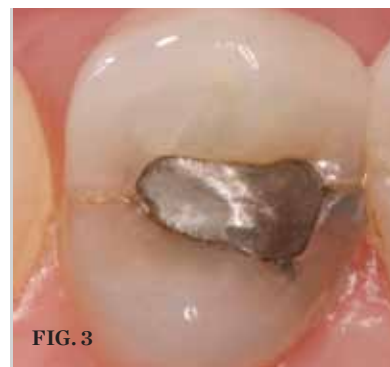
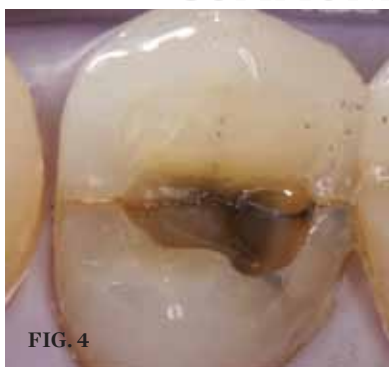
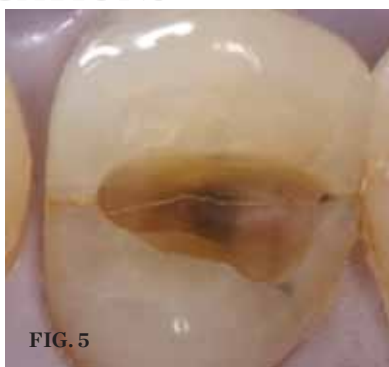
“floor” (also the term the author and his team uses with patients). If, however, there was a cracked “floor,” the filling would reinforce the tooth and a crown would be recommended (Figure 3 through Figure 5). The patient agreed to have the filling replaced despite a lack of a clinical catch and without radiographic decay present, with the hope that her tooth was not cracked. The patient understood that crowning the tooth would be recommended if it showed internal (pulpal floor) cracks.

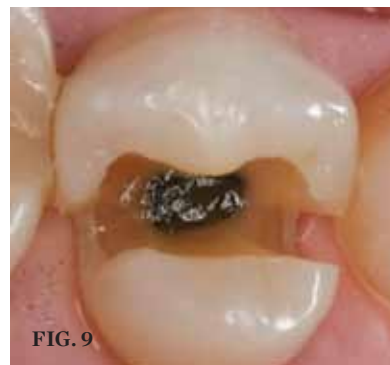
The cracked marginal ridges were prepared as conservative boxes using the same round-ended bur, resulting in a fairly narrow (buccal to lingual) but deep cavity preparation with round internal line angles (Figure 9). The depth of the preparation, along with the narrow buccal-lingual dimension, resulted in a high C-factor restoration with increased risk of cusp failure in the future. To minimize the influence of the C-factor and shrinkage stress, and to make the tooth more crack-tolerant in

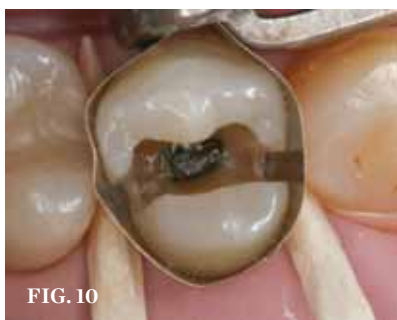
To perform this procedure, the axial walls and marginal ridges were first restored. A standard Tofflemeyer matrix band was selected instead of a sectional matrix because the proximal boxes were fairly narrow and lingual to the contact area (Figure 10). The tooth was etched for 15 seconds and then rinsed, after which excess water was suctioned away. Two layers of 3M™ ESPE™ Adper™ Single Bond Plus Adhesive were applied according to manufacturer instructions. After evaporating the solvent with a light stream of air for 5 seconds, the bonding agent was polymerized for 10 seconds. The axial walls were restored with two increments of Filtek Supreme Ultra

**RESTORATION STEPS (10.)** A standard Tofflemeyer matrix band was selected instead of a sectional matrix because the proximal boxes were fairly narrow and lingual to the contact area. **(11.)** Filtek™ Supreme Ultra Universal Restorative was used for the first cervical increment and the marginal ridges on the mesial and distal. **(12.)** Ribbon THM 4 mm was prepared and the resultant Ribbon/Supreme fiber was placed on the tooth and adapted closely to the dentin without suffering pullback. **(13.)** Simulated fiber placement with color to help the reader visualize where the fiber was placed. Ribbon THM 4 mm covered the pulpal floor and extended slightly up the axial and proximal walls. **(14.)** After fiber placement, successive layers of Filtek™ Supreme Ultra Universal Restorative were placed and sculpted. **(15.)** A series of contouring and polishing discs was used on the axial walls. **(16.)** A super-fine interproximal diamond was used to refine the shape sculpted into the occlusal surface. **(17.)** A rubber cup was used for initial polishing. **(18.)** A brush with polishing paste completed the finishing. **(19.)** The Filtek™ Supreme Ultra Universal Restorative polished easily to an enamel-like luster and blended nicely with the adjacent tooth structure.

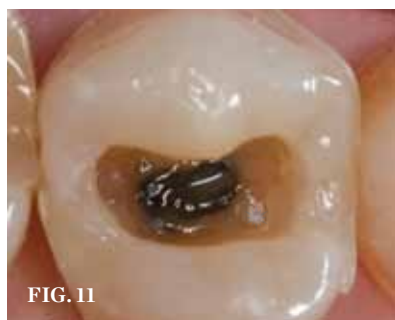
universal restorative. Shade A3B was used for the first cervical increment and A1E was used to form the marginal ridges on the mesial and distal. Each increment was cured for 10 seconds (Figure 11). The matrix band was removed and the Ribbond was selected and prepared for bonding. The author selected 4 mm Ribbond THM and cut off a 5-mm section. The fiber was then wet with 3M™ ESPE™ Adper™ Scotchbond™ Multi-Purpose Plus Adhesive (an unfilled resin without solvent or water) on a paper pad. Next, a small amount of shade A3B Filtek Supreme Ultra universal restorative was pressed into the fiber. The resultant Ribbond-Supreme fiber was placed on the tooth and adapted closely to the dentin without suffering pullback (Figure 12 and Figure 13).

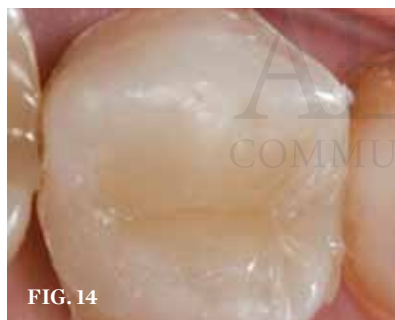
After fiber placement, a layer of A3B restorative was placed, carefully adapted, and cured. Finally, a layer of A1E restorative was placed, adapted, sculpted into shape, and cured (Figure 14). The restoration was finished with a series of 3M™ ESPE™ Sof-Lex™ Contouring and Polishing Discs for the axial walls (Figure 15). Next, a super-fine interproximal diamond was used to refine the shape sculpted into the occlusal surface (Figure 16). A rubber cup was used for initial polishing, followed by a brush with polishing paste (Figure 17 and Figure 18). As previously mentioned, Filtek Supreme Ultra polishes easily to

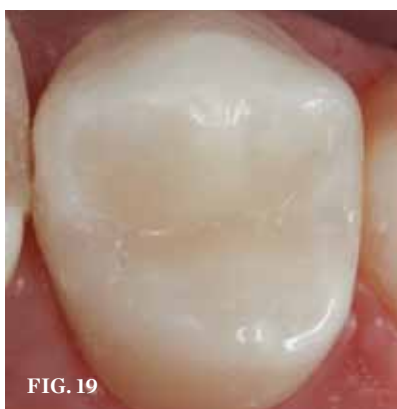
an enamel-like luster and blends nicely with the adjacent tooth structure (Figure 19). After removal of the rubber dam, the occlusion was checked. At the conclusion of treatment, the patient was given the opportunity to see what was found during treatment with a series of intraoral images. The patient was happy that her tooth was not cracked internally, and with the improved appearance of the tooth as well as the fact that she would not need a crown.
